Manhole Inspection Summary

Manhole # S35QQ1011MH

Inspection ☐ Is Incomplete Rating: **4) Poor**

Location Address: **404 WINSTON AVE**

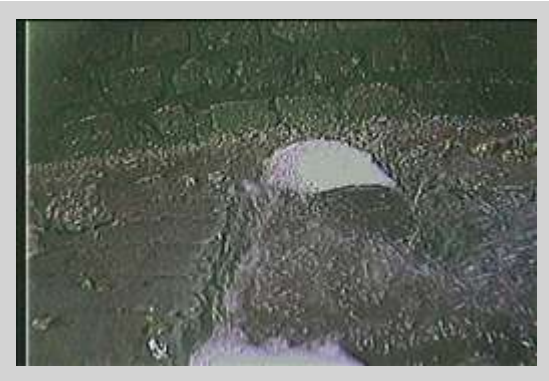
8 in. Circular Gravity Sewer Pipe Out @ 12 O'Clock

Pipe Material: **Clay** ☐ Pipe Lined

Invert Depth: **10.56** (ft.) Flow Characteristics: **Fast**

Infiltration: **None** Pipe Seal Cond: **Unknown**

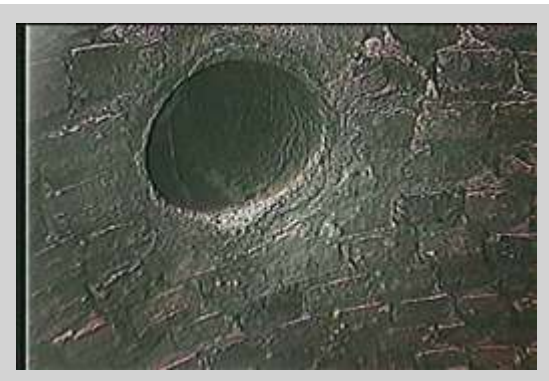
8 in. Circular Gravity Sewer Pipe In @ 4 O'Clock

Pipe Material: **Clay** ☐ Pipe Lined

Infiltration: **None** Pipe Seal Cond: **Broken**
